20 MM A.A. GUN

20 mm Machine Gun Mechanisms, Marks 2 and 4
20 mm Gun Barrels, Marks 2, 3, 4, and 4 Mod. 1
20 mm Sights, Marks 2, 4, 4 Mod. 1, and 5
20 mm Magazines, Marks 2 and 4
20 mm Shoulder Rests, Marks 2, 4, 5, and 5 Mod. 1

O.P. 911 is changed as follows:

The purpose of this addendum is to amplify the instructions contained in O.P. 911, and to describe new tools and methods intended to increase the efficiency and safety of operation of the 20 mm A.A. gun. The following items are covered herein:

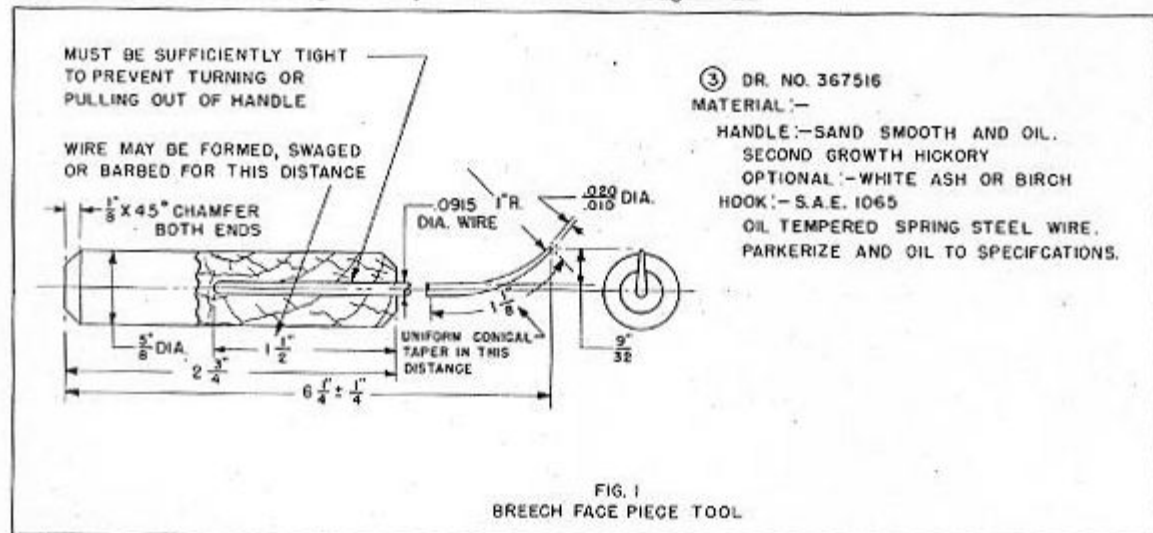
(a) BREECH FACE PIECE TOOL

Figure 1 has been approved for production and will be furnished in the tool rolls of new guns. For guns now in service, the tool of Figure 1 may be made up by any activity that considers it desirable. A number of similar tools have been submitted by the Fleet. In one case, a common file handle was used as a grip for the tool. In another design, one end of a rod was pointed in a manner similar to that shown in Figure 1 and the other end was formed into a loop to serve as an integral handle. Any of these methods may be employed, provided that the pointed end of the tool conforms generally to that shown in Figure 1.

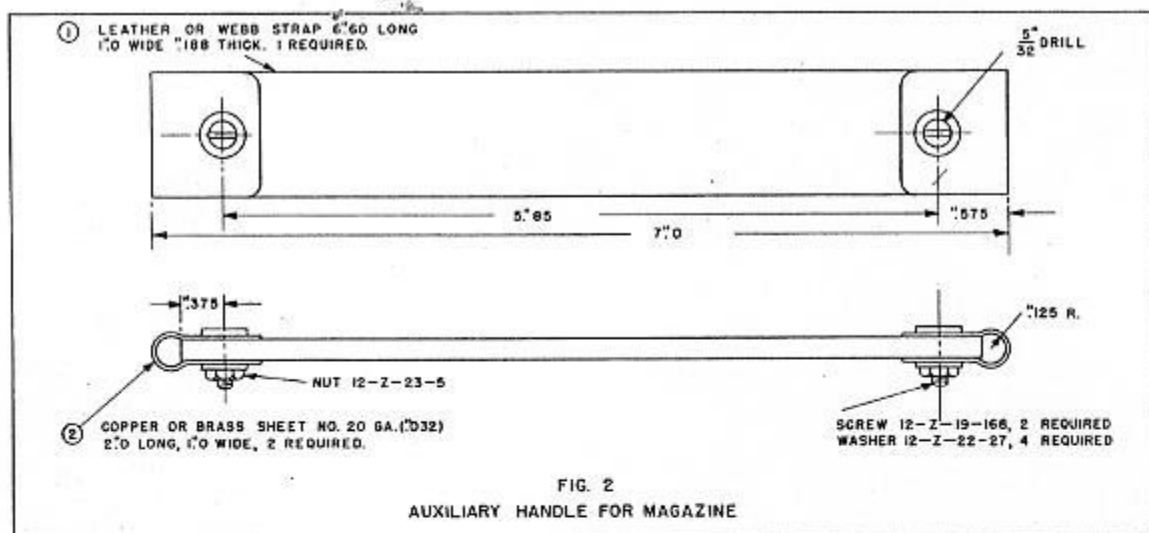
(b) AUXILIARY HANDLE FOR MAGAZINE

Difficulties have been encountered in removing 20 mm magazines from Type X ready service storage chests similar to NYD Norfolk Sk. No. 47237 (HuOrd. Dr. No. 332979) - 20 mm Ready Service Ammunition Chest. In this type of chest, the magazines are racked with their axes horizontal, and the handles are not readily accessible through the opening at the top of the chest.

Figure 2 shows an auxiliary handle that has been developed to aid in lifting magazines from chests of this type. The handle is fastened to the magazine by the two casing bolts which are on top when the magazine is stowed. The handle is not available for distribution to the service but may be manufactured and used by any activity that so desires.

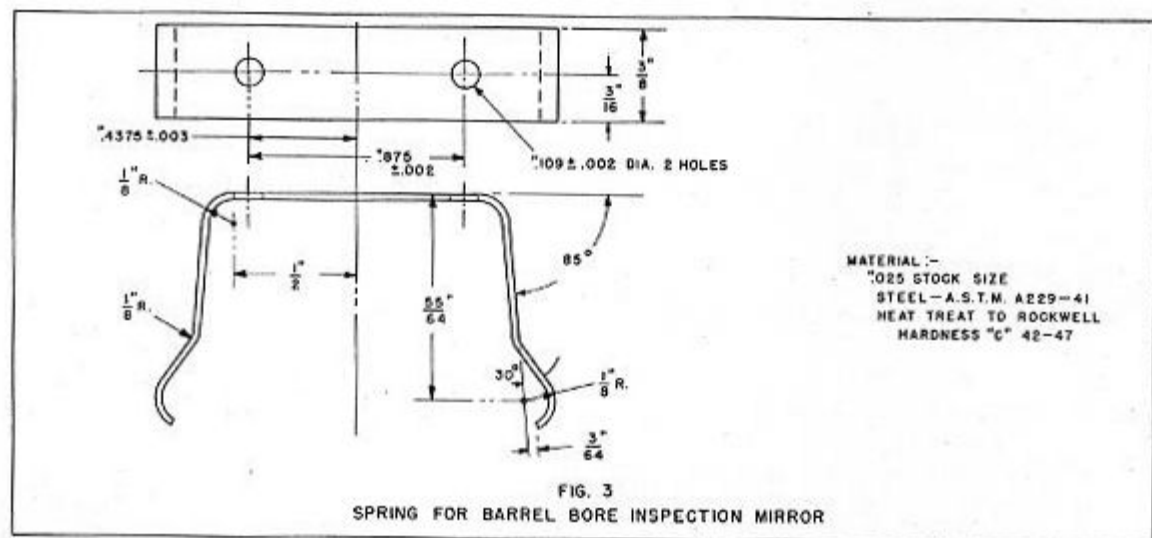
(i) SPRING FOR BARREL BORE INSPECTION MIRROR

A new design of barrel bore inspection mirror has recently been approved for production. The new mirror assembly differs from the present design (367517) in that the mirror and its supporting arm can be folded back into the frame to facilitate stowage, and the sides of the frame fit snugly (with spring action) in the magazine slot in the breech casing. Until such time as the new type of mirror assembly becomes available, the bore inspection mirrors now on hand may be altered to provide a retaining spring for securing the mirror assembly to the casing. Figure 3 shows the details of a spring which is intended to be fastened to the under side of the present bore inspection mirror base (367517-2 or 3) by means of rivets. The spring should be located so that the rivets are about $59/64$ " from the rear of the base. Authorization is given for the manufacture and installation of the spring by any service activity that considers it desirable.
