20mm Mk 4 Mod 2 Gun Mounts Stabilization Report

Owner – Texas Parks and Wildlife Department
Project – Stabilize Four 20mm Gun Mounts

Scope of Project

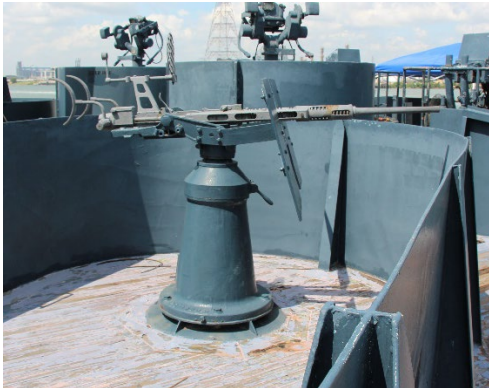
The mount was found to be in overall stable condition and in a similar condition as all eight of the ship's current 20mm mounts, not just the four-undergoing conservation. It was painted with polyurethane paint in 2019 over the existing coatings. Several parts of the mount were either missing or severely deteriorated. The column raising handwheel and the pedestal head cover, the plate that keeps rainwater from entering the mount, was missing. The missing plate allowed the hardware securing the carriage to the stand to become heavily corroded yet intact. The left and right cheek plates were missing from the cradle. The carriage locking bolt was frozen in place and with at least half of the bolt missing from corrosion. The carriage and cradle were tack welded together to keep the gun from elevating. Additionally, the pedestal head locking catch was found welded in the locked position preventing the gun from rotating.

Its gun was found to be in a state of deterioration with the visible signs of the long-term effects of corrosion. This condition is consistent with that of the other eight 20mm guns on the ship. It was coated with polyurethane paint in 2019 over the existing coatings. The internal mechanical components of the trigger assembly were wholly corroded away. The buffer springs and interior of the trigger casing were heavily corroded and showed signs of water standing being retained inside the gun. The breach casing was covered in paint and the breech block was frozen in the place by rust. The barrel was filled with rust and externally had pitting where the barrel spring interfaced with the barrel. The barrel casing was heavily pitted on the interior lower surface, where rainwater would collect. Surprisingly, where parts were fitted with tight tolerances the interfacing surfaces of those parts were free of degradation, given the overall poor condition of the gun.

Mount #8 – mounted on ship, prior to removal

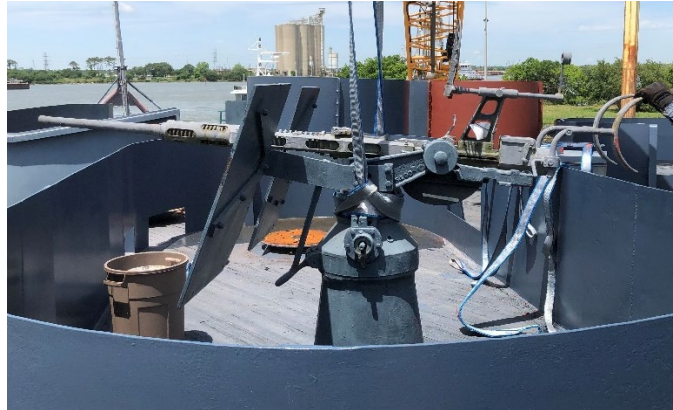
The mount was found to be in overall stable condition and in a similar condition as all eight of the ship's current 20mm mounts, not just the four-undergoing conservation. Several parts of the mount were either missing or severely deteriorated. The column raising handwheel and the pedestal head cover, the plate that keeps rainwater from entering the mount, was missing. The missing plate allowed the hardware securing the carriage to the stand to become heavily corroded yet intact. The carriage locking bolt was frozen in place and with at least half of the bolt missing from corrosion. The carriage and cradle were tack welded together to keep the gun from elevating and rotating. Additionally, the pedestal head locking catch was found welded in the locked position preventing the gun from rotating.

Its gun was found to be in a state of deterioration with the visible signs of the long-term effects of corrosion. This condition is consistent with that of the other eight 20mm guns on the ship. The internal mechanical components of the trigger assembly were corroded entirely away. The buffer springs and interior of the trigger casing were heavily corroded and showed signs of water standing being retained inside the gun. The breach casing was covered in paint and the breech block was frozen in the place by rust. The barrel was filled with rust and externally had pitting where the barrel spring interfaced with the barrel. The barrel casing was heavily pitted on the interior lower surface, where rainwater would collect. Surprisingly, where parts were fitted with tight tolerances the interfacing surfaces of those parts were free of degradation, given the overall poor condition of the gun.

Mount #5 – mounted on ship, prior to removal

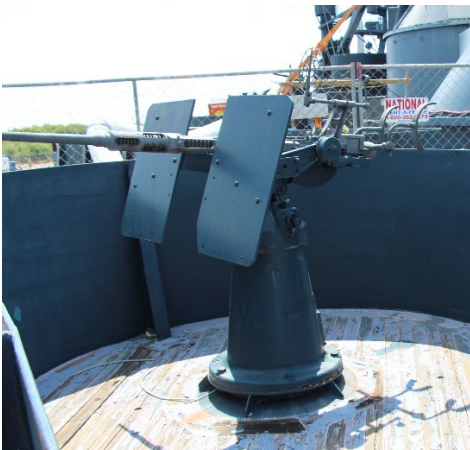
The mount was found to be in overall stable condition and in a similar condition as all eight of the ship's current 20mm mounts, not just the four-undergoing conservation. It was coated coat of polyurethane paint in 2019 over the existing coatings. Several parts of the mount were either missing or severely deteriorated. The column raising handwheel and the pedestal head cover, the plate that keeps rainwater from entering the mount, was missing. The missing plate allowed the hardware securing the carriage to the stand to become heavily corroded yet intact. The carriage locking bolt was frozen in place and with at least half of the bolt missing from corrosion. The carriage and cradle were tack welded together to keep the gun from elevating. The pedestal head locking catch was found welded in the locked position preventing the gun from rotating.

Its gun was found to be in a state of deterioration with the visible signs of the long-term effects of corrosion. This condition is consistent with that of the other eight 20mm guns on the ship. The internal mechanical components of the trigger assembly were utterly corroded away. The buffer springs and interior of the trigger casing were heavily corroded and showed signs of water standing being retained inside the gun. The breach casing was covered in paint and the breech block was frozen in the place by rust. The barrel was filled with rust and externally had pitting where the barrel spring interfaced with the barrel. The barrel casing was heavily pitted on the interior lower surface, where rainwater would collect. Surprisingly, where parts were fitted with tight tolerances the interfacing surfaces of those parts were free of degradation, given the overall poor condition of the gun.

Mount #6 – mounted on ship, prior to removal

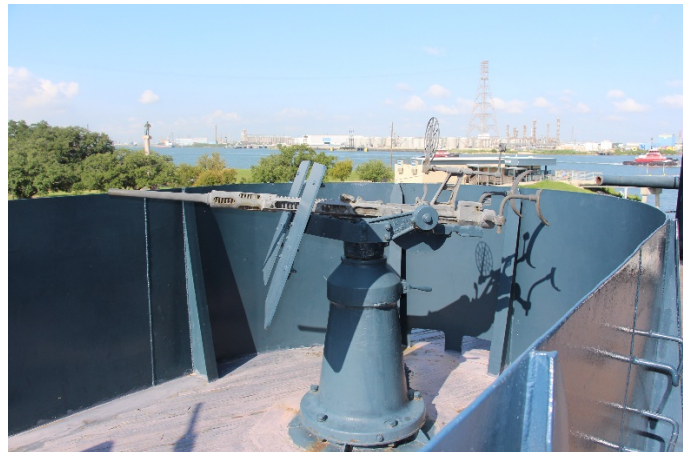
The mount was found to be in overall stable condition and in a similar condition as all eight of the ship's current 20mm mounts, not just the four-undergoing conservation. Several parts of the mount were either missing or severely deteriorated. The column raising handwheel and the pedestal head cover, the plate that keeps rainwater from entering the mount, was missing. The missing plate allowed the hardware securing the carriage to the stand to become heavily corroded yet intact. The carriage locking bolt was frozen in place and with at least half of the bolt missing from corrosion. The carriage and cradle were tack welded together to keep the gun from elevating. However, the gun could rotate freely.

Its gun was found to be in a state of deterioration with the visible signs of the long-term effects of corrosion. This condition is consistent with that of the other eight 20mm guns on the ship. The internal mechanical components of the trigger assembly were corroded entirely away. The buffer springs and interior of the trigger casing were heavily corroded and showed signs of water standing being retained inside the gun. The breach casing was covered in paint, and the breech block was frozen in the place by rust. The barrel was filled with rust and externally had pitting where the barrel spring interfaced with the barrel. The barrel casing was heavily pitted on the interior lower surface, where rainwater would collect. Surprisingly, where parts were fitted with tight tolerances the interfacing surfaces of those parts were free of degradation, given the overall poor condition of the gun.

Mount #3 – mounted on ship, prior to removal

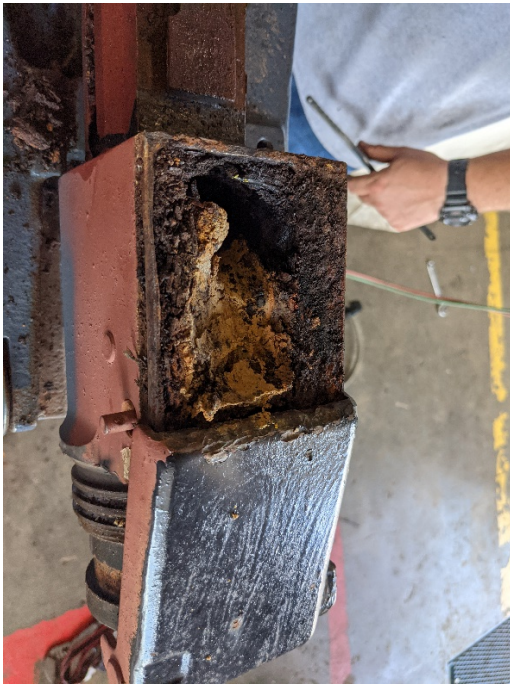
Corrosion filled interior of trigger casing/breech casing

- Final Disassembly – The last three major components of the gun to be removed were the trigger casing, breech block/breech bolt assembly, and the barrel. The trigger casing was removed with relative ease. The breech block/breech bolt assembly was frozen in place with corrosion. The breech block was fused to the breech by corrosion. After heat cycling the afflicted area and soaking with copious amounts of penetrating oil (Kroil), the breech block/breech bolt assembly was removed from the gun with great difficulty by placing a soft steel alloy rod (softer than the face of the breech block) down the gun barrel and applying percussive force to the rod over a long period with a hammer. This methodology separated the breech block/breech assembly from the breach casing without damaging the gun components.

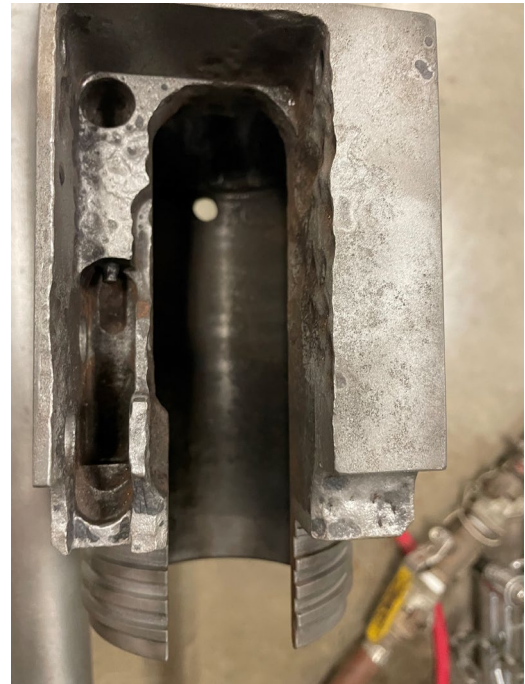
Breech casing after treatment, prior to final preparation for parkerization

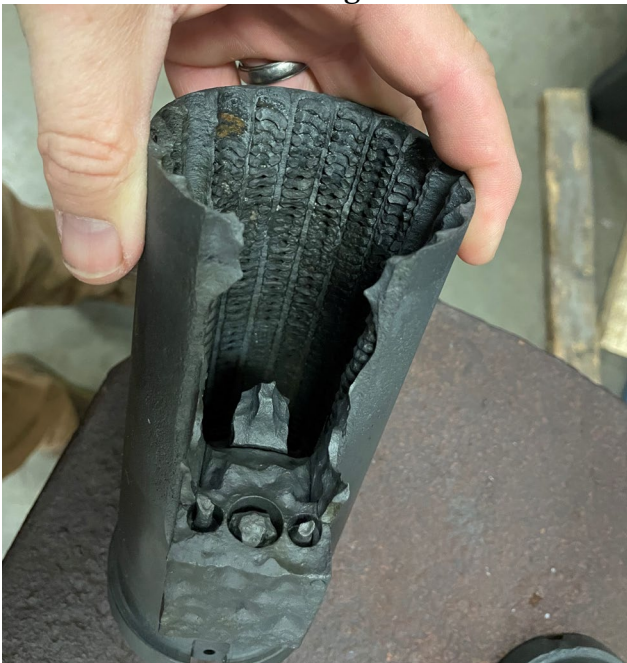
Representative trigger casing after electrolysis.
The interior of the casing is almost entirely corroded away, revealing the corrosion damaged springs.

- Electrolysis Treatment – Electrolysis was used to clean paint remanent and corrosion from the hard-to-clean interiors of specific components. The barrel spring casing and trigger casing for all four mounts went through electrolysis. The breech casings for mounts #5 (2019.1002.29) and #6 (2019.1002.30) went through electrolysis because they were able to be separated from their barrels. None of the barrels went through electrolysis due to their chromium content and the possible release of hexavalent chromium gas. Hexavalent chromium is a known carcinogen byproduct when alloys containing chromium undergo electrolysis.

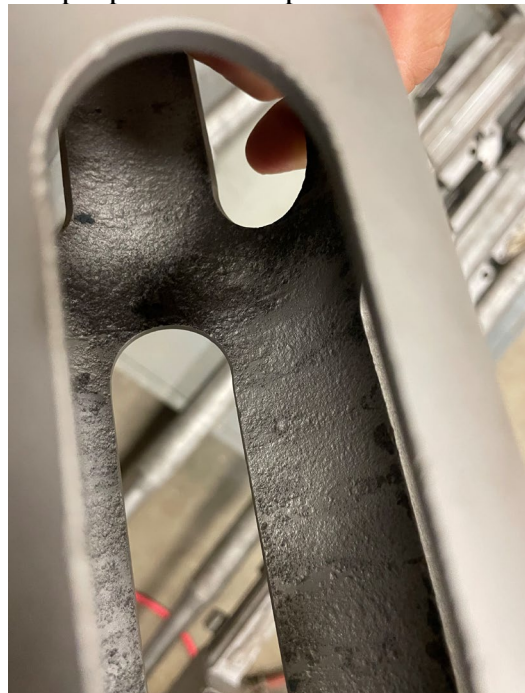
Representative barrel spring casing after electrolysis and bead blasting. Note the heavy pitting in the interior surface.

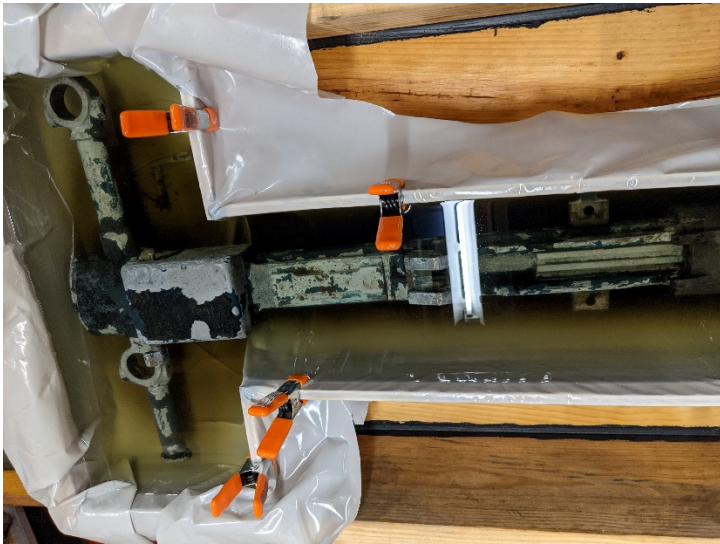
Representative gun in rust chelating bath

- Rust Chelation Treatment—The gun was soaked in a rust chelating agent (EvapoRust) for two weeks. After the rust chelating bath was complete, the gun was further disassembled.

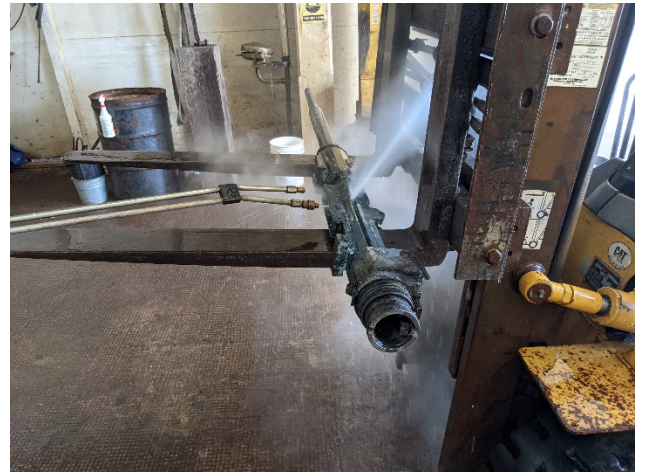
Representative gun being pressure washed to remove loose rust scale and rust chelating agent.

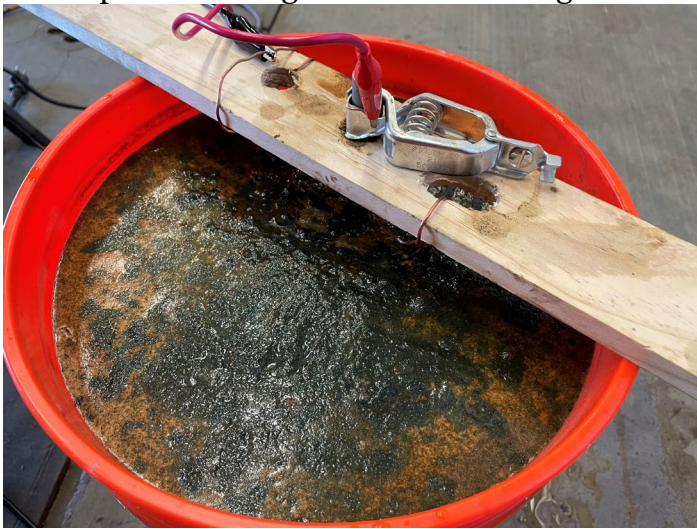
Trigger casing undergoing electrolysis. The film floating on top is rust.

The electrolytic solution used was one cup Arm & Hammer Super Washing Soda (Na_2CO_3) per gallon of tap water. Each component was suspended in the solution and a mild steel anode was placed through the open center of each component. The electric current supplied was 12 volts dc with upwards of 30 amps for up to seven days, with daily cleaning of the steel anode.

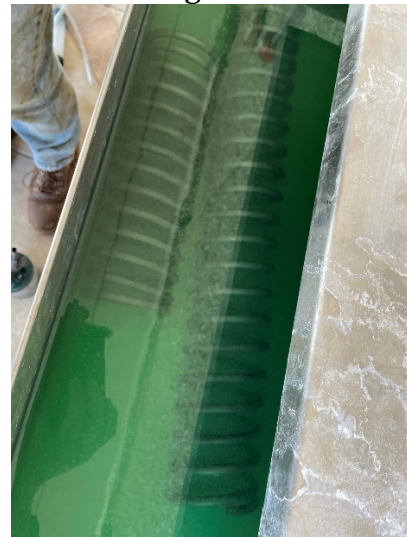
Barrel springs undergoing parkerization.

- Parkerization – all gun components were bathed in acetone, bead blasted with a glass bead/aluminum oxide blast media (10/70 mesh, 220 grit), washed with acetone, heated evenly to at least 100 degrees F with a heat gun, and parkerized with zinc phosphate. After leaving the parkerization tank, each component was washed with hot water and placed in a bath of very light oil (WD-40) and allowed to rest for a few days.

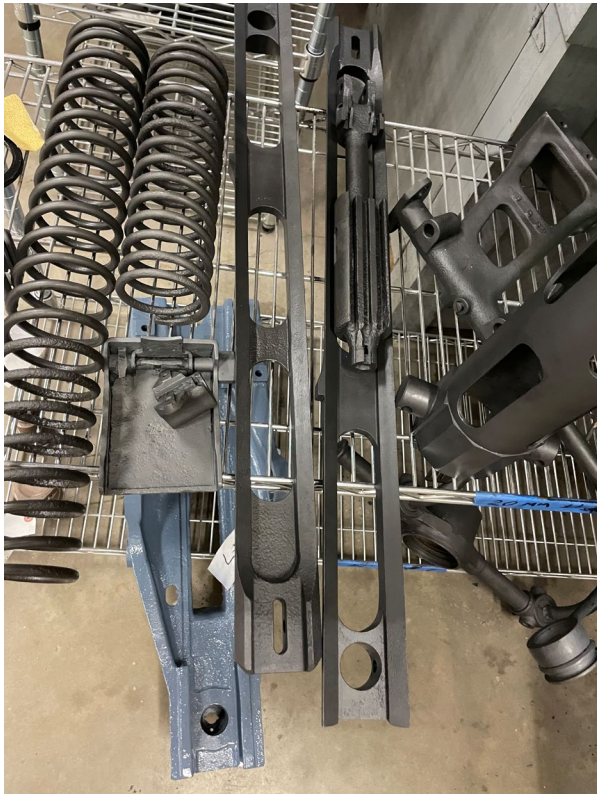
Representative barrel springs, breech bars, breech block, and trigger case cover after parkerization

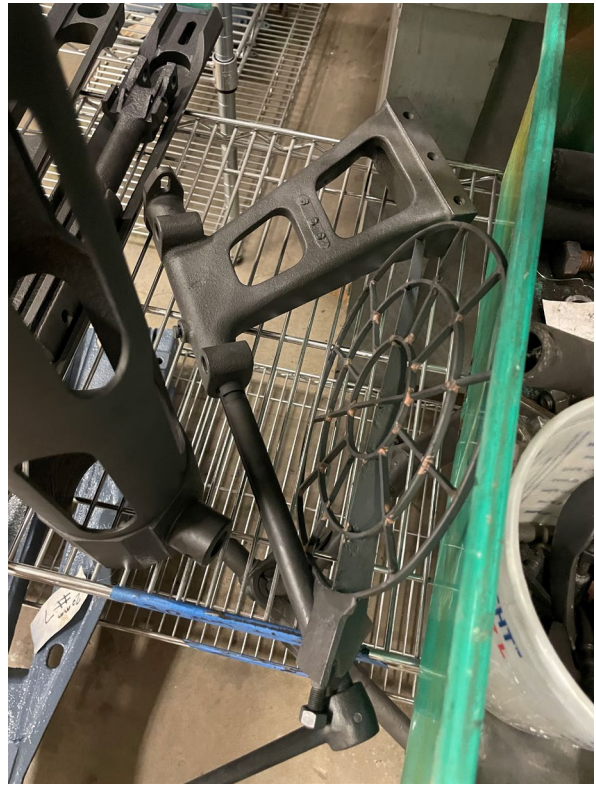
Representative barrel casing, ring sight, and ring sight mounting bracket after parkerization

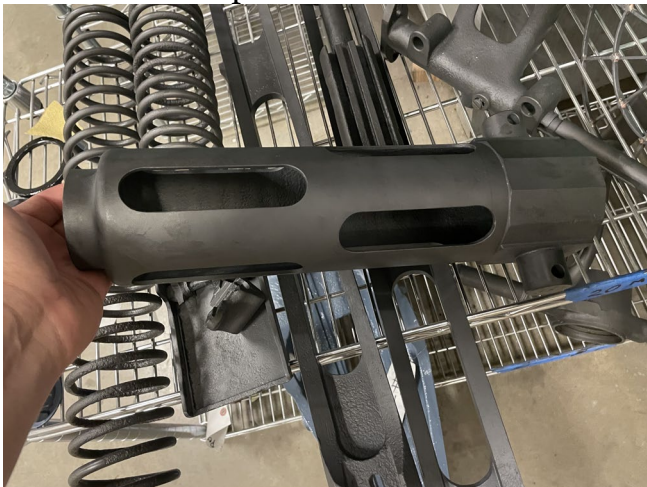
Representative barrel spring casing after parkerization

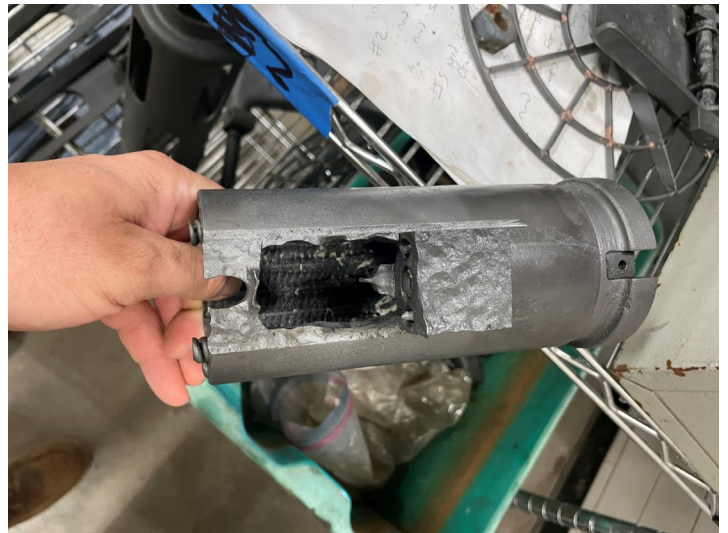
Representative trigger casing after parkerization

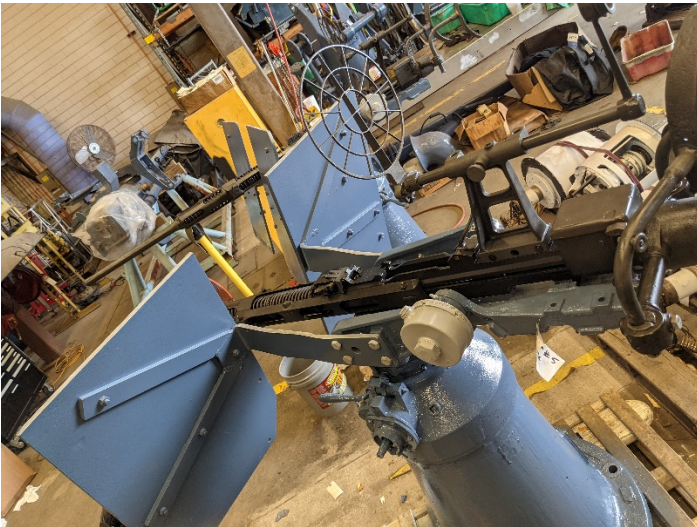
Representative mount after being reassembled with gun parkerized, prior to gun being painted

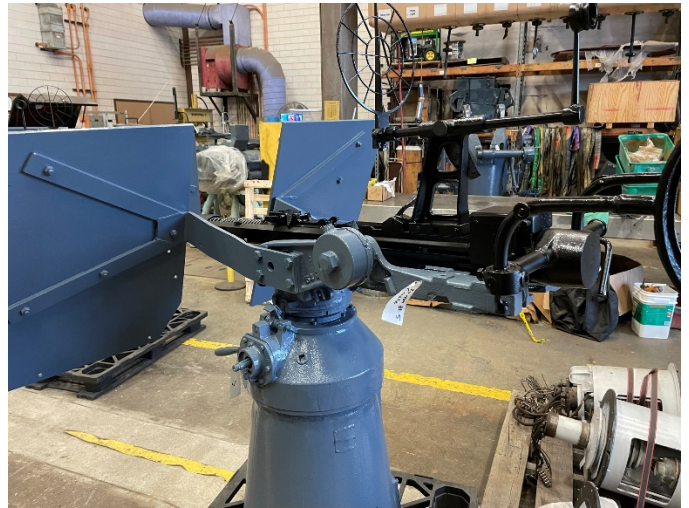
Representative assembled mount after gun has been painted black.

- Reassembly and Final Preservative Treatments – After the parkerization process was complete, the gun was reassembled and the exterior painted black with PSX 1001 (PPG). The gun was then reinstalled on the gun mount. The interior of the gun and its moving parts were coated with Royal Purple Compressor Oil to preserve the gun's interior further.

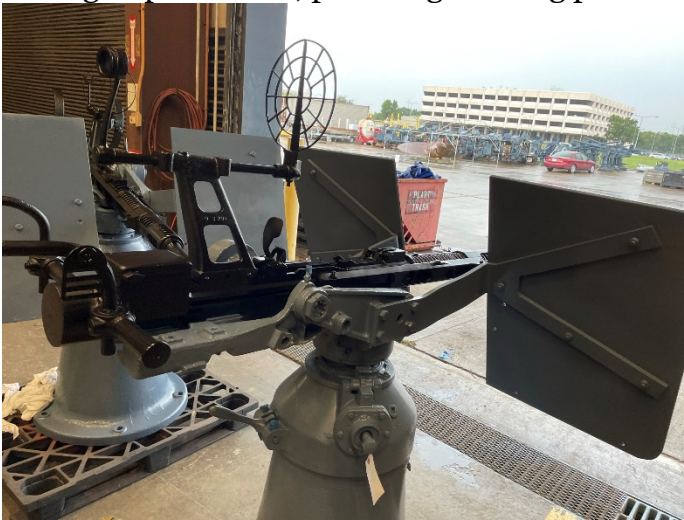
Two completed mounts awaiting heat shrink wrap.

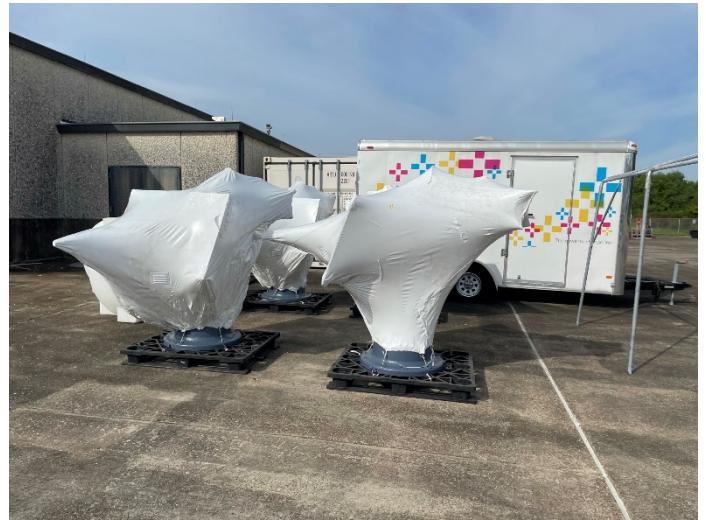
All four mounts heat shrink wrapped and stored outside.

Once all work was complete on each mount, the mount was placed on a pallet and covered with heat shrink wrap to protect the guns from the elements while awaiting reinstallation on the ship. The heat shrink encapsulation is vented to prevent a microclimate from forming.
