MACHINE GUN BULLETIN NO. 2

JUNE 1942

TWENTY MILLIMETER

MACHINE GUN

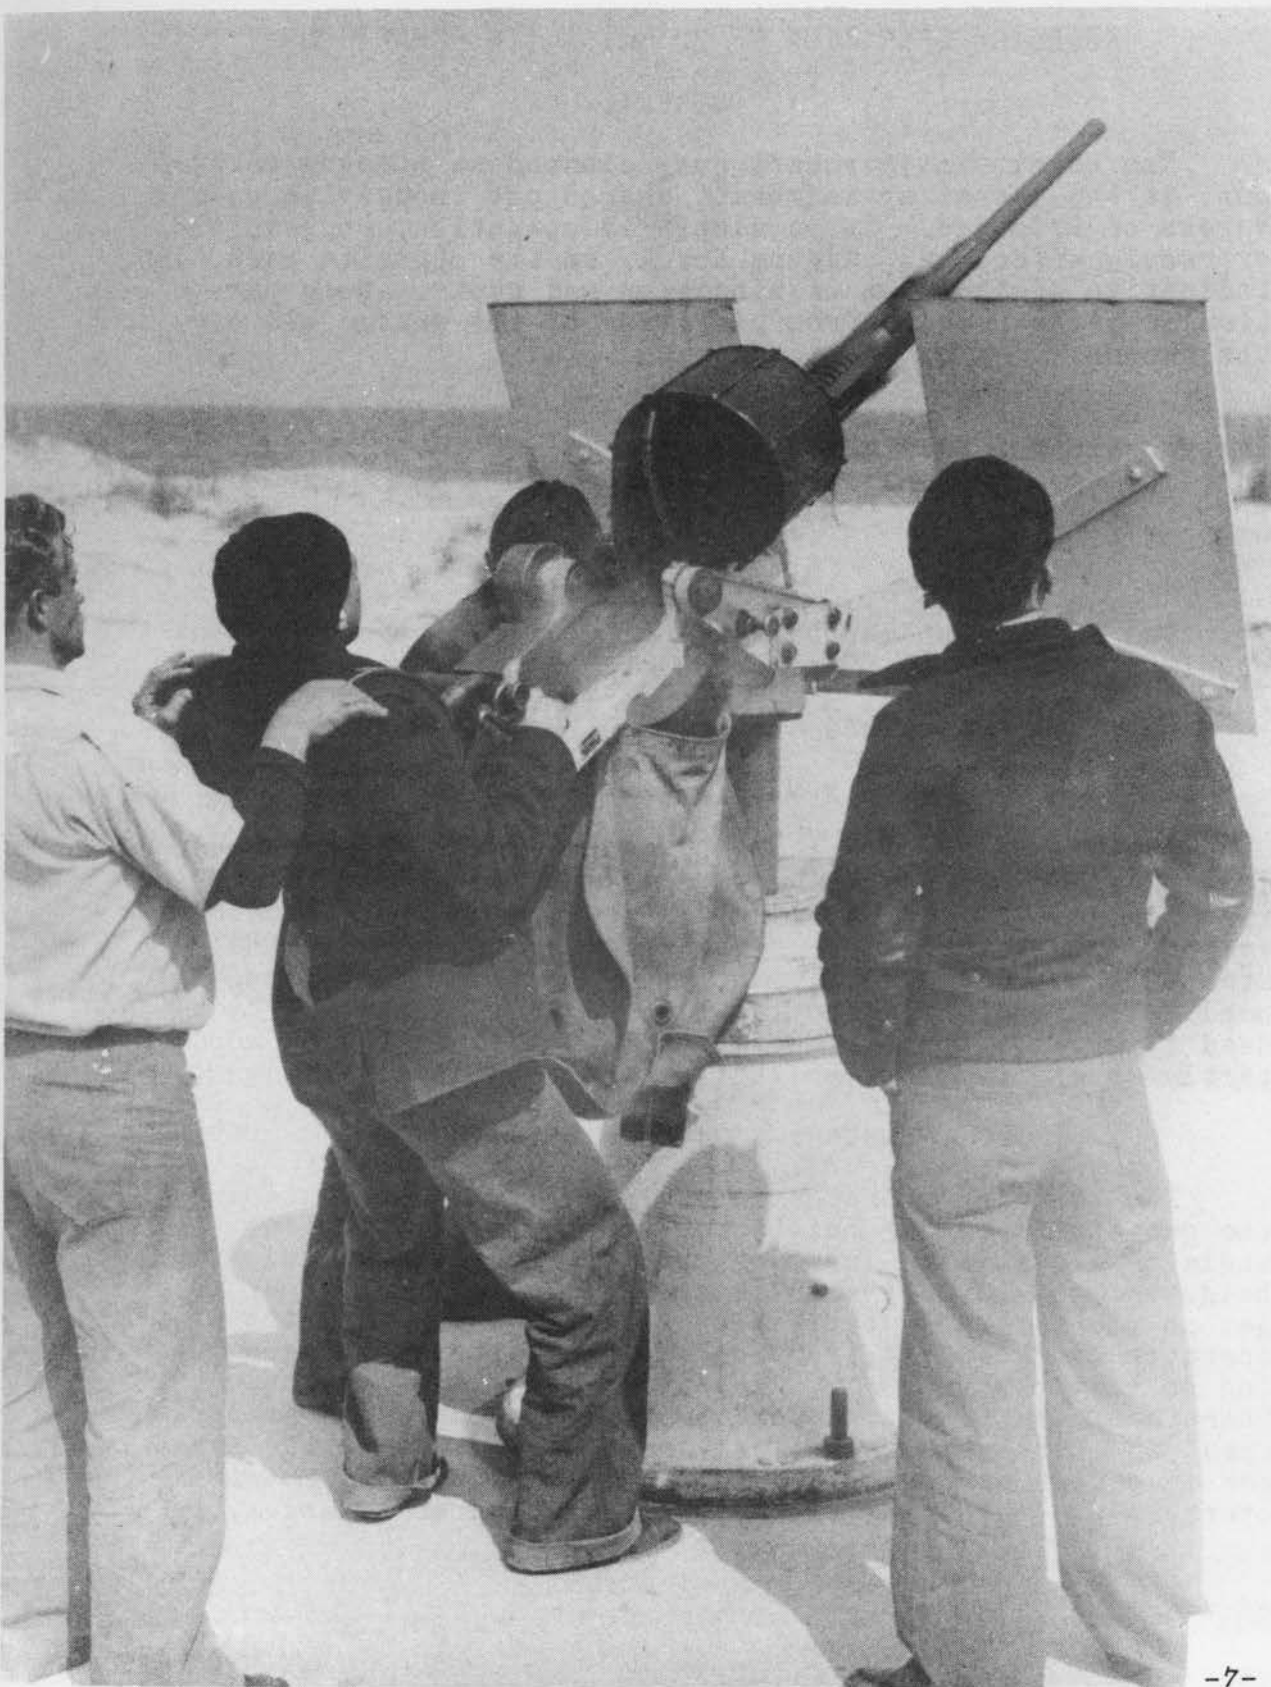
FIGURE 1

The 20 mm. anti-aircraft gun, classed as a heavy machine gun, is the latest anti-aircraft weapon put in service by the Bureau of Ordnance. It is simple in operation, rugged, and extremely effective. Figure No. 1, on the opposite page, is indicative of the lack of vibration and smoke. Note particularly the freedom from vibration of the muzzle and of the gunner.

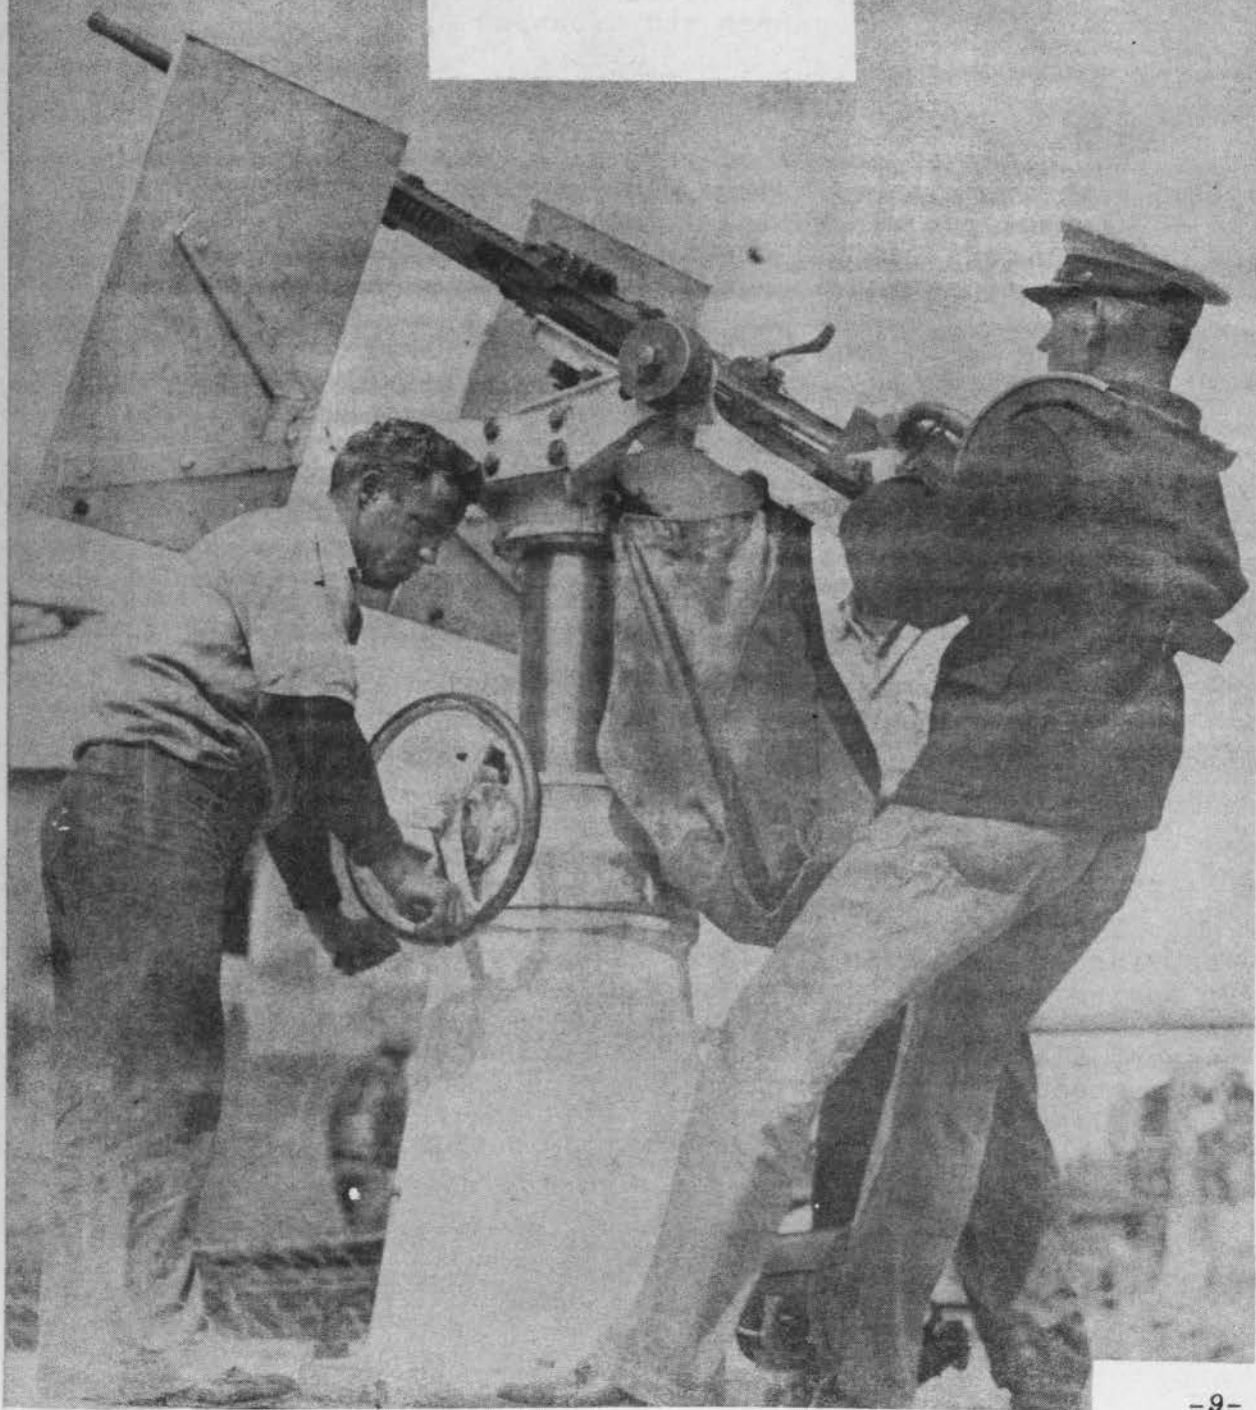
FIGURE 2

should be assigned as gunner as often as possible in order to get the feel of the stance required of the gunner and to realize it is impossible for the gunner to get this stance unless the trunnions are operated properly. (It should be noted, however, that as a planes comes in from very high angles the gunner *must* bend his knees to get on the target. A demonstration will show the men that this is natural and that the trunnions are normally elevated to the maximum for such conditions.) Above all, the trunnion operator *must not turn to observe target or tracers*. Refer to figure No. 2 for proper stance for gunner and trunnion operator.

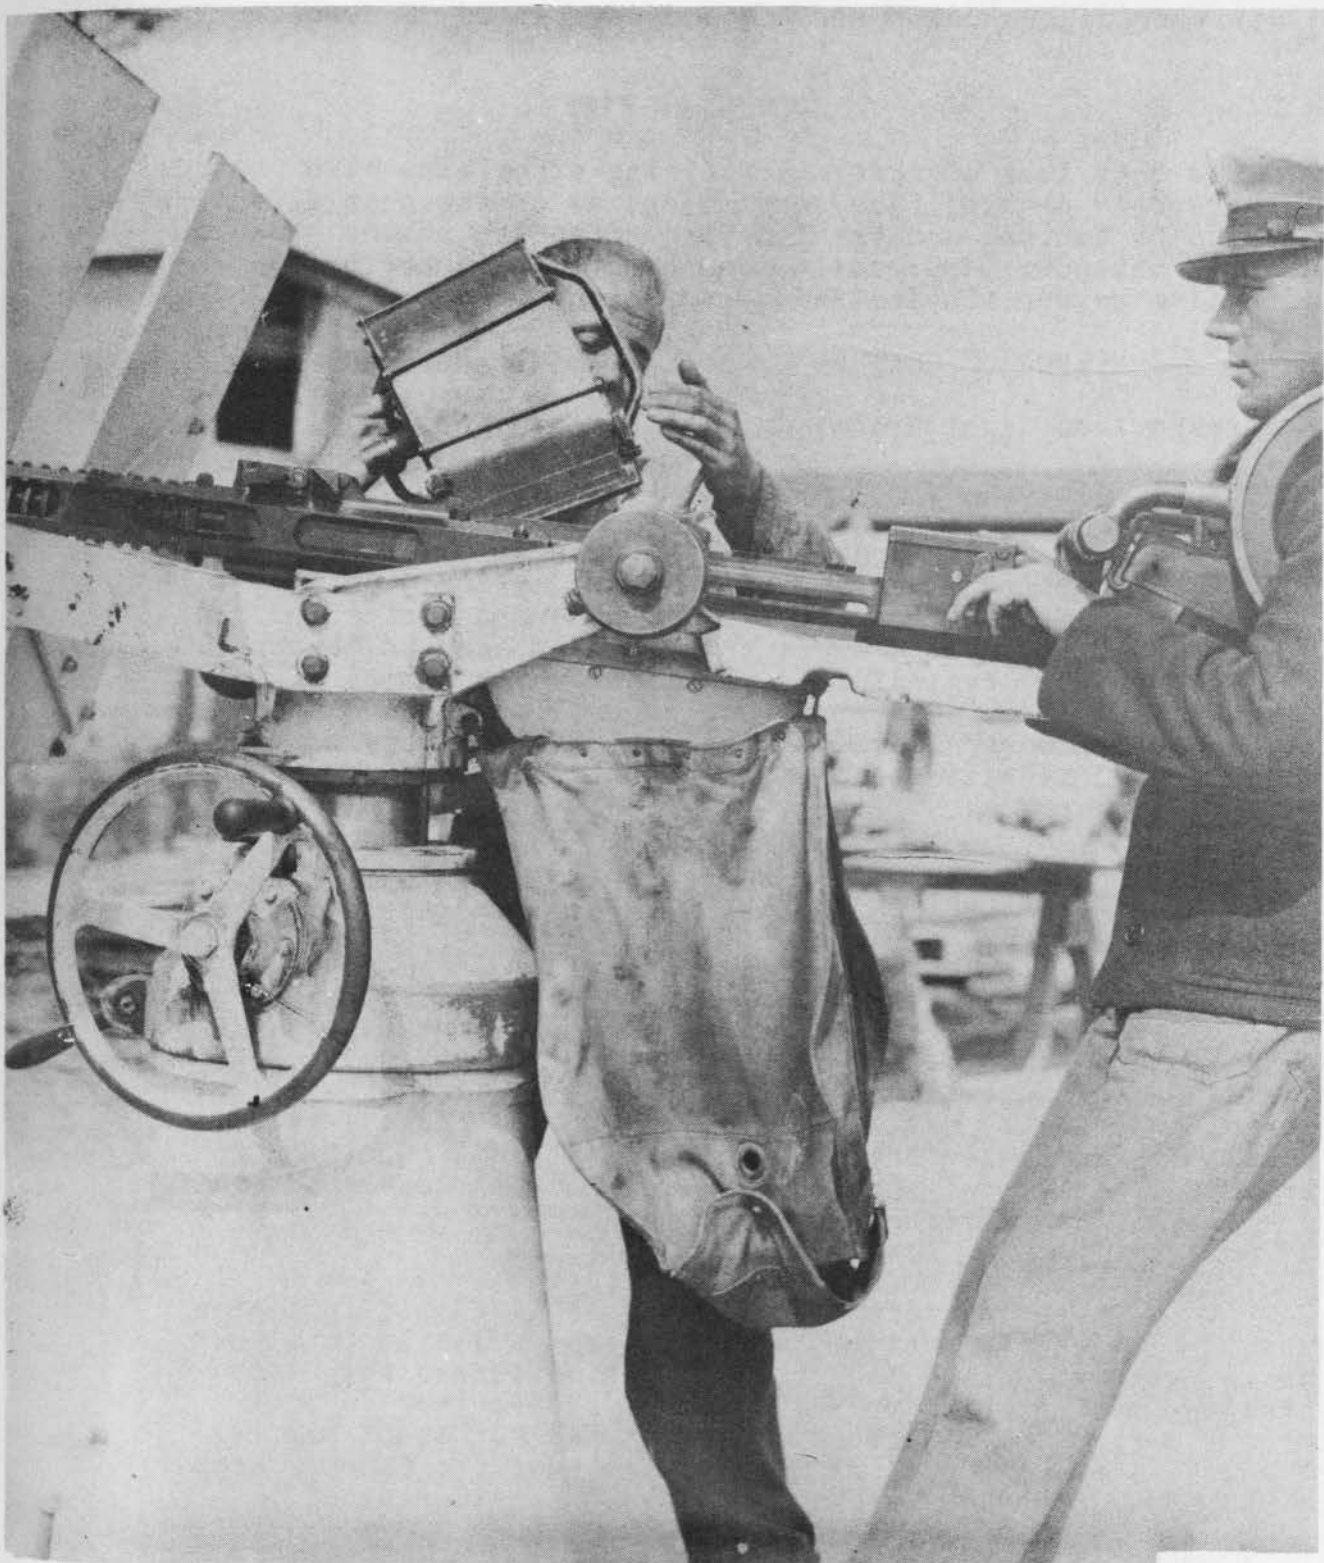
FIGURE 3

Figure No. 3, showing the loader removing a magazine is an excellent example of the proper way both to load and unload.
